PUBLIC NOTICE

PERMIT APPLICATION: NRS # 06.097

APPLICANT: Metro Water Services
1600 2nd Avenue North
Nashville, Tenn. 37208
615-862-4922

PROJECT DESCRIPTION: The applicant proposes to remove eight existing aerial sewer line crossings of Richland Creek and replace them with three below-grade gravity crossings. The alterations are part of the Nashville Overflow Abatement Program. In addition to the installation of the three Richland Creek crossings, there will be one main-line (12") and three smaller line (8" and 10") crossings of tributaries, two areas of extra rip rap (50 linear feet and 130 linear feet), and the removal of the eight aerial crossings structures down below the water line level. Excavation will be by mechanical means, when rock is encountered a hoe-ram will be used. In areas where hoe-ramming access is not available or the rock is too thick, controlled blasting will be utilized.

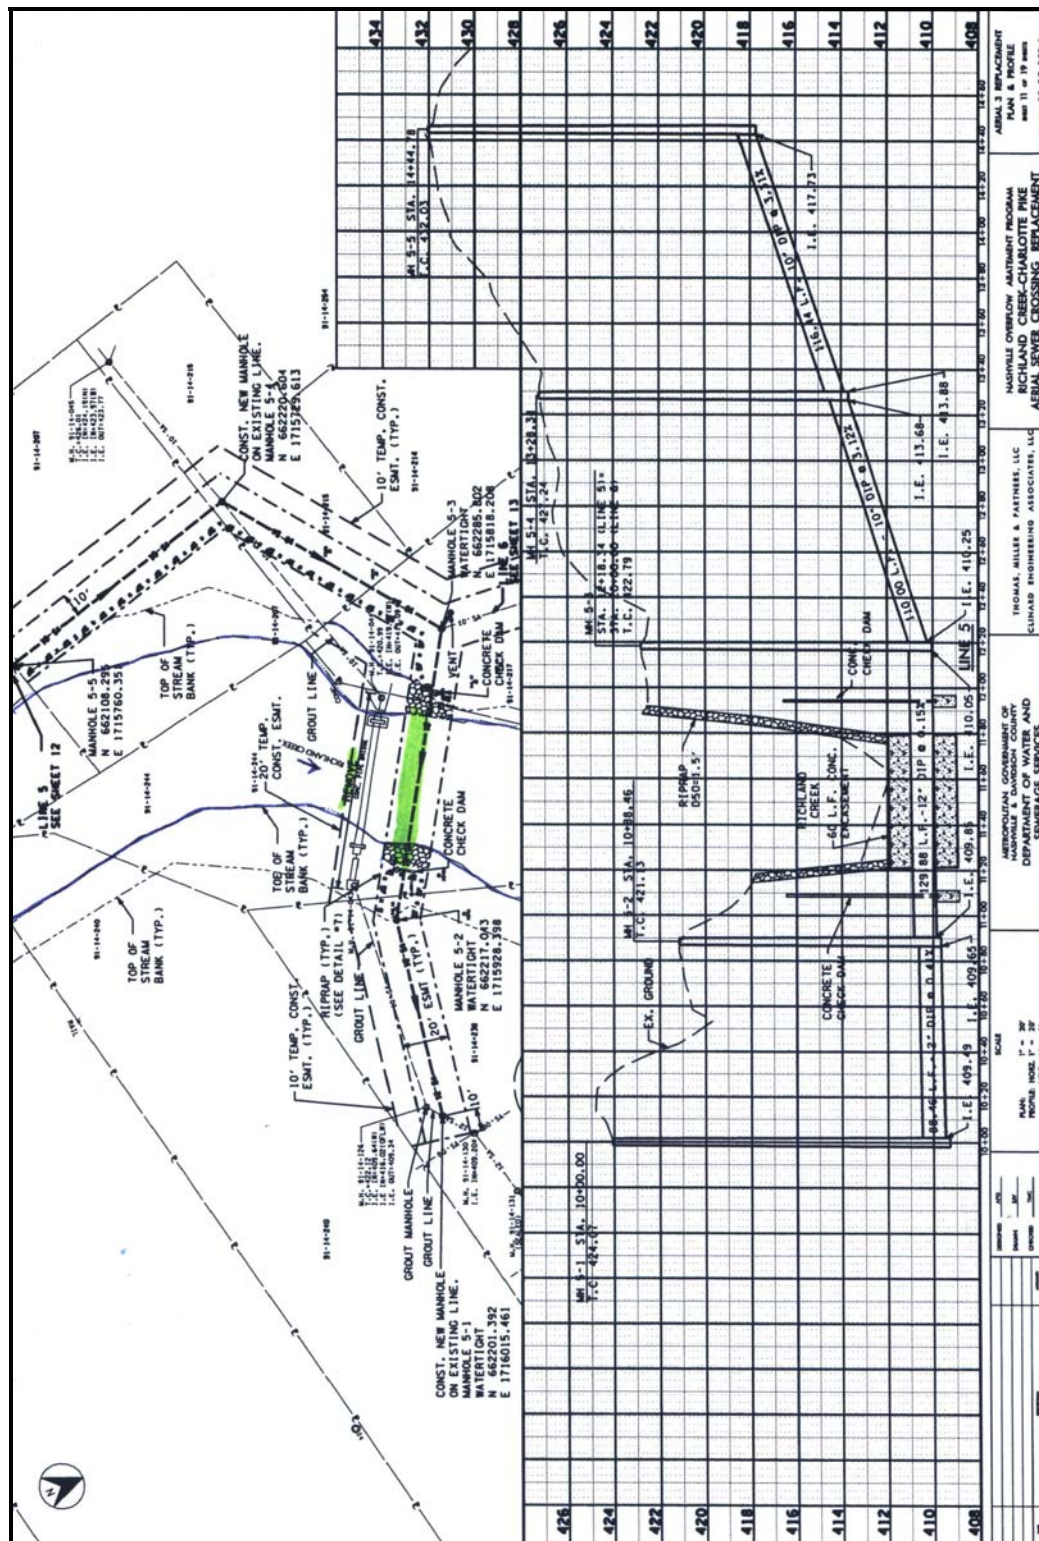
Figure 6: Crossing 3 area – Remove 1 aerial, install new crossing
